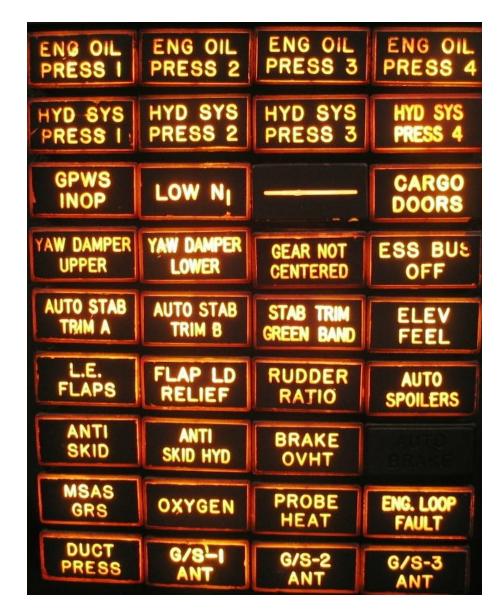
ENG OIL PRESS 1, 2, 3, or 4 below 35 PSI

HYD SYS PRESS is below limits. Monitoring EDP and ADP press lights on FE panel will not go out if system is pressurized by electric pump.

GPWS INOP Ground Proximity Warning System not working properly.

LOW N1 Inhibited on ground when landing flaps selected. Flashing: Engine(s) N1 less than 50% above 10,000 or less than 45% below 10,000 with Nacelle Anti-Ice on.

CARGO DOORS If during Takeoff: Pack Valve Switches...CLOSE. land at nearest suitable airport. Check FE panel to see if more than one light illuminated. If FWD CARGO DR, AFT CARGO DR, or SIDE CARGO DR lights on FE panel illuminated, accomplish depressurization procedure. With resettable pilot's NOSE DR light installed, and only one light illuminated on FE panel, press RESET switch on FE door panel to extinguish pilot's light and rearm system for subsequent warning.

YAW DAMPER UPPER Turn coordinator is out of sequence with flap position. With Flaps Up, Turn Coordinator is deactivated, still operating. Normally illuminated if flaps are extended if: Standby Power Light is On.

YAW DAMPER LOWER Turn coordinator is out of sequence with flap position. With Flaps Up, Turn Coordinator still operating. Normally illuminated if flaps are extended if: Standby Power Light is On.

GEAR NOT CENTERED repeater Light. There is an unlocked gear condition. Body Gear Steering Unlocked. Illuminates for either a PRIMARY or ALT body gear unlocked indication.

ESS BUS OFF Essential AC Bus is Not Powered.

AUTO STAB TRIM A "A" Autopilot Stab Trim has failed, or an out of trim condition as existed for 12 seconds.

AUTO STAB TRIM B "B" Autopilot Stab Trim has failed, or an out of trim condition as existed for 12 seconds.

L.E. FLAPS Leading Edge Flaps not in agreement with flap handle.

BRAKE OVHT Any brake is approaching an overheat condition.

PROBE HEAT Any probe heat light is on. This is a repeater. It means either you have a heater failure with the probe switch ON or, the heater is OFF.
